[Docket No. FAA-2004-19960; Directorate Identifier 2004-CE-47-AD; Amendment 39-14153; AD 2005-13-16]

Airworthiness Directives; The New Piper Aircraft, Inc. PA-34 Series Airplanes

2005-13-16 The New Piper Aircraft, Inc.: Amendment 39-14153; Docket No. FAA-2004-19960; Directorate Identifier 2004-CE-47-AD.

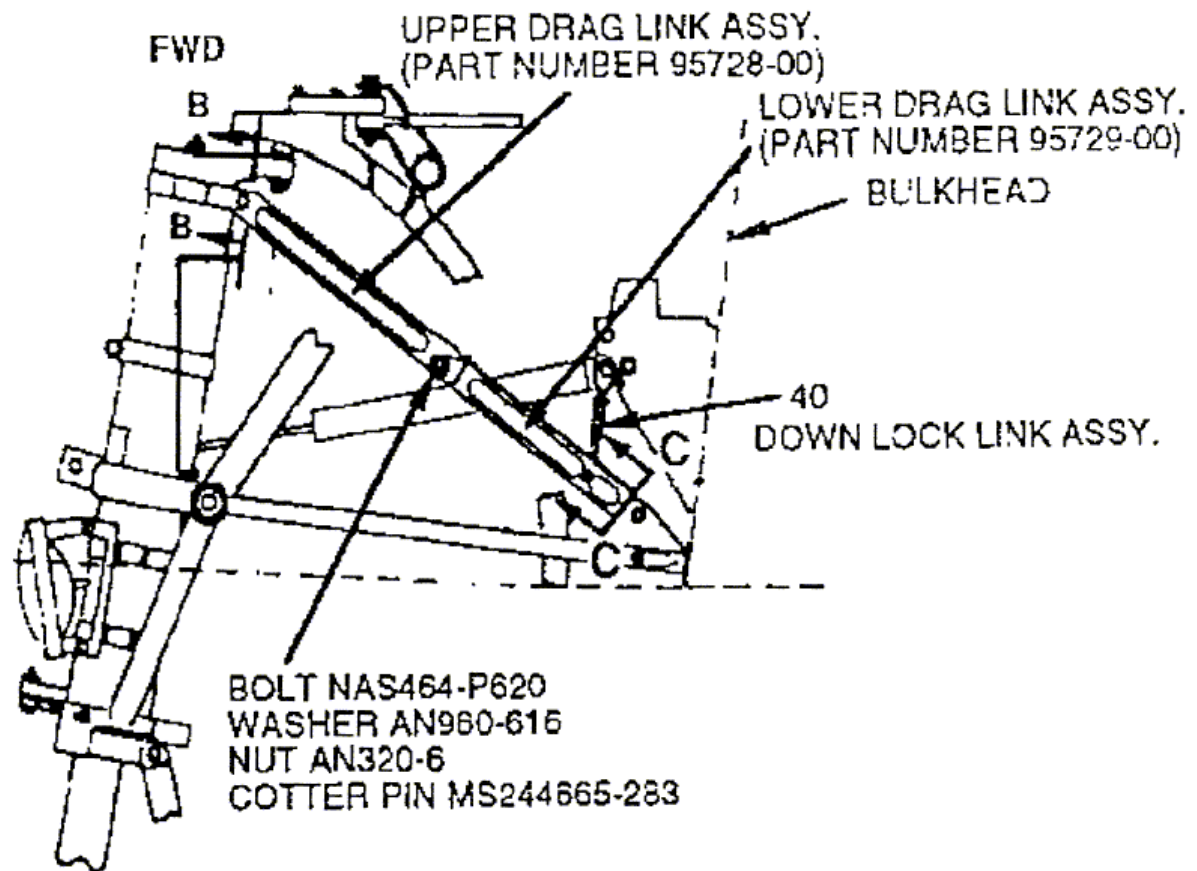
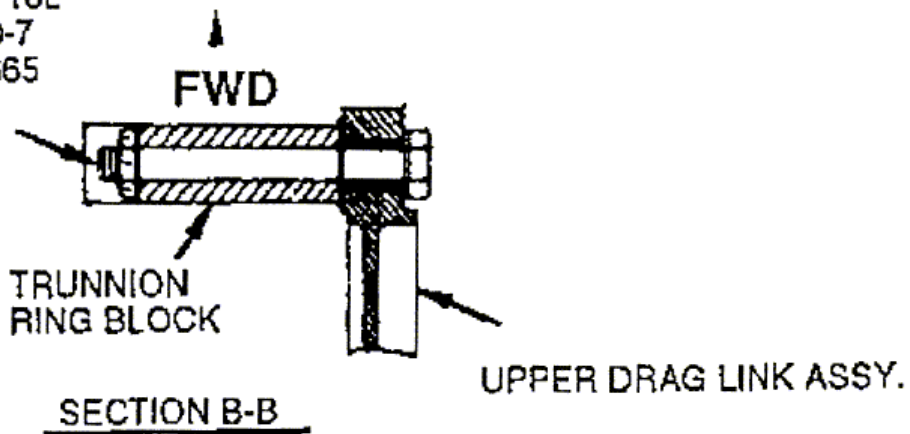
Figure 1.

What events have caused this AD? Several incidents where the nose landing gear (NLG) on The New Piper Aircraft, Inc. (Piper) PA-34 series airplanes collapsed caused us to issue AD 93-24-14, Amendment 39-8762 (58 FR 65115, December 13, 1993). AD 93-24-14 currently requires the repetitive replacement of the bolt and stack up that connect the upper drag link to the nose gear trunnion on all Piper PA-34 series airplanes.

AN7-35
AN960-716
OR
AN960-716L
AN320-7
MS24665

UPPER DRAG LINK - TO -
GEAR CONNECTION

Actions	Compliance	Procedures
<p>(1) Replace the bolt and stack up that connects the upper drag link to the nose gear trunnion with new parts (or FAA-approved equivalent part numbers (P/N)) of the following:</p> <p>(i) Piper P/N 400 274 (AN7-35) bolt;</p> <p>(ii) Piper P/N 407 591 (AN960-716L) washer, as applicable;</p> <p>(iii) Piper P/N 407 568 (AN960-716);</p> <p>(iv) Piper P/N 404 396 (AN320-7) nut; and</p> <p>(v) Piper P/N 424 085 cotter pin.</p>	<p>Within the next 100 hours time-in-service (TIS) after January 28, 1994 (the effective date of AD 93-24-14), unless already done within the last 400 hours TIS before January 28, 1994 (compliance with AD 93-24-14). Repetitively replace thereafter at intervals not to exceed 500 hours TIS. Continue to repetitively replace until the actions in paragraphs (e)(2) and (e)(3) of this AD begin.</p>	<p>Follow Figure 1 of this AD.</p>
<p>(2) Do the inspections, replacements, and other corrective actions specified in Table 1 “Specified Maintenance” of Piper Service Bulletin No. 1123A, dated November 30, 2004.</p>	<p>Within the next 100 hours TIS after August 8, 2005 (the effective date of this AD), unless already done. Repetitively inspect thereafter at the intervals referenced in the Inspection Time column of the <i>INSTRUCTIONS</i> paragraph in Piper Service Bulletin No. 1123A, dated November 30, 2004.</p>	<p>Follow The New Piper Aircraft, Inc. Service Bulletin No. 1123A, dated November 30, 2004.</p>
