SERVICE No. 1123B BULLETIN

Date: April 20, 2006 (M)

**SUBJECT: PA-34 SERIES AIRCRAFT NOSE GEAR
 INSPECTION AND PRODUCT IMPROVEMENTS**

ATA: 3220

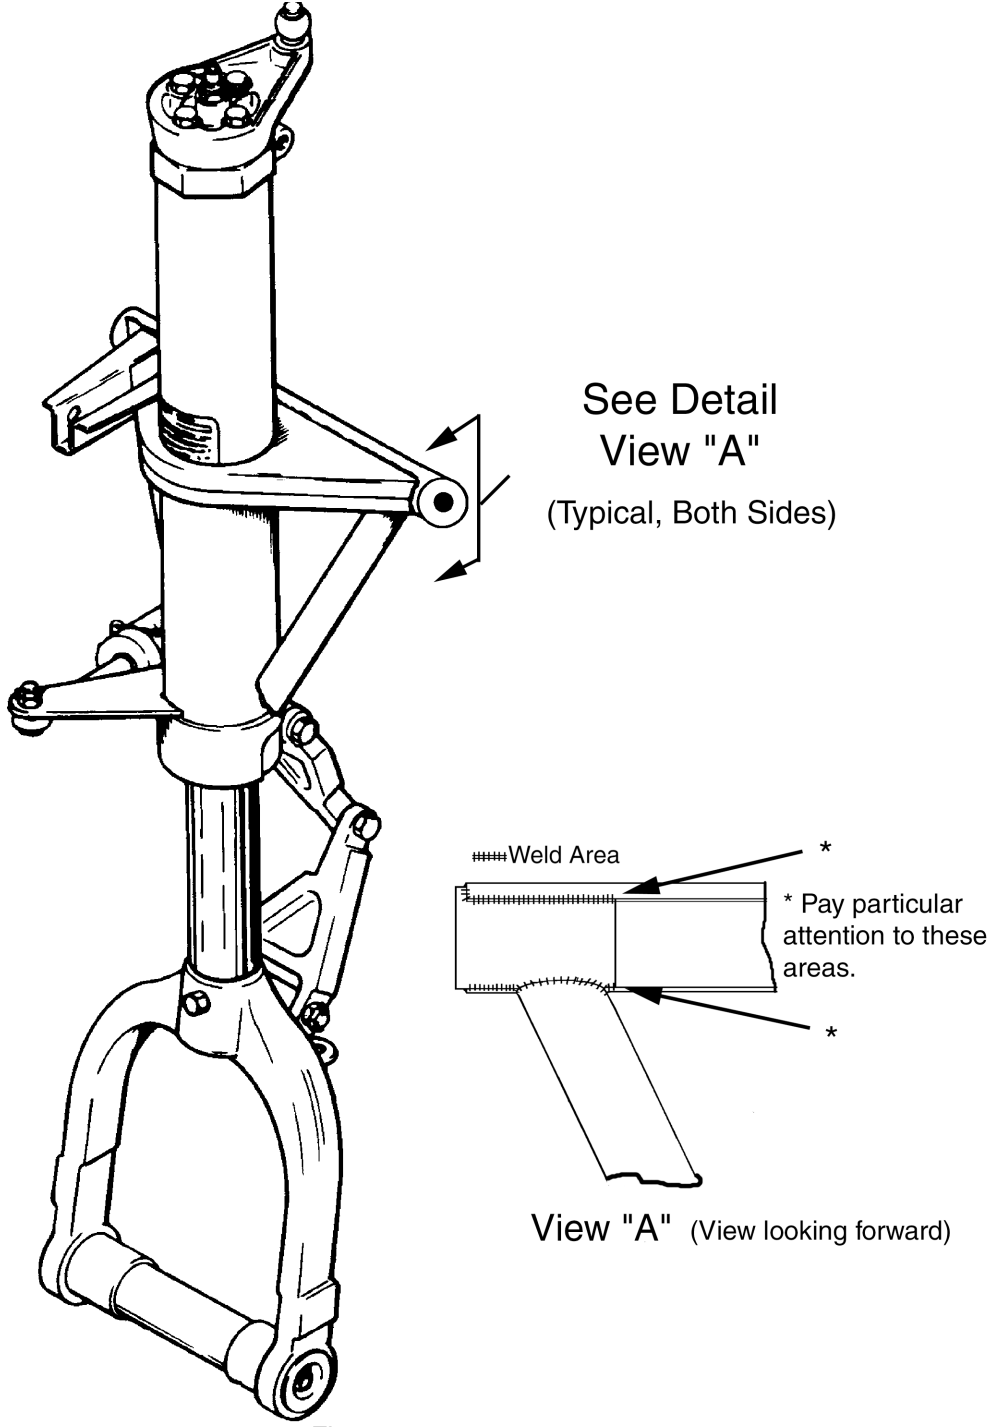
Figure 1
 Trunnion Inspection
 (See Table 1, Item 3)

3. Visually inspect (2000 hrs. initial) the nose gear trunnion (P/N 95723-00, -05, -06) for cracks in the area of attachment to the nose gear mount assembly (See Figure 1) using supplemental lighting and a 10X magnifier				0

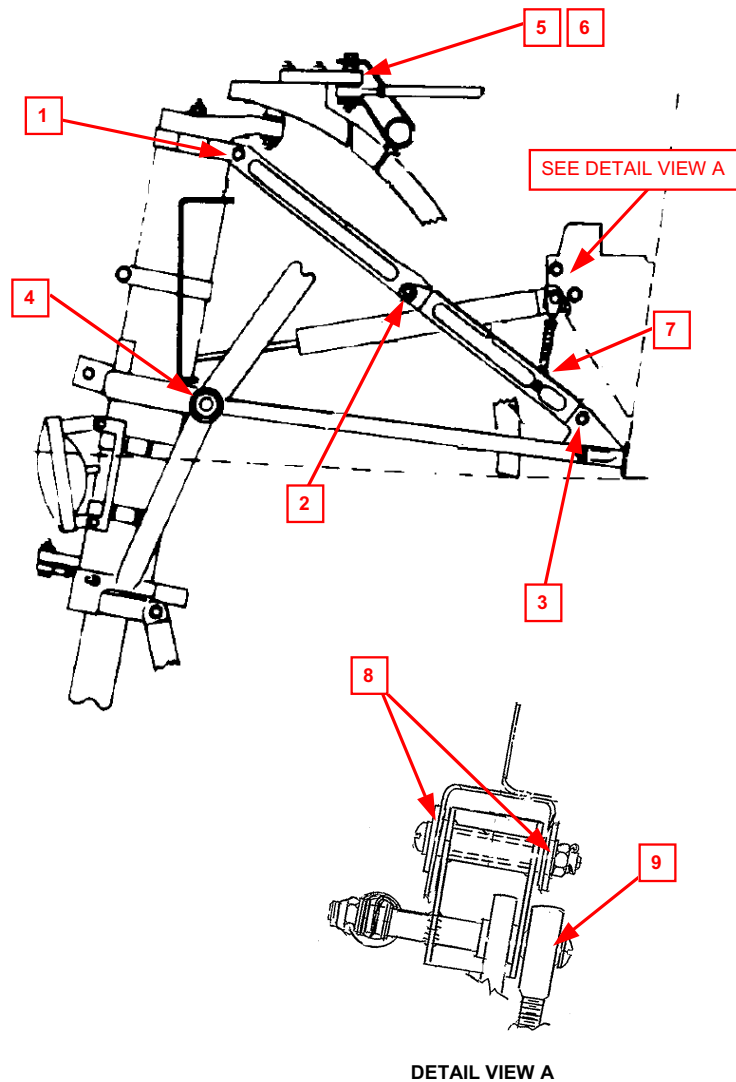
Figure 2
Service Wear Limit Locations

Table 3 is a "Wear Limits Chart" that can be used to determine the acceptable /or replacement condition for the listed parts that were inspected per Instructions Step 1. in this Service Bulletin. Visually inspect all bolts/pins for wear, damage, or corrosion. Replace as required.

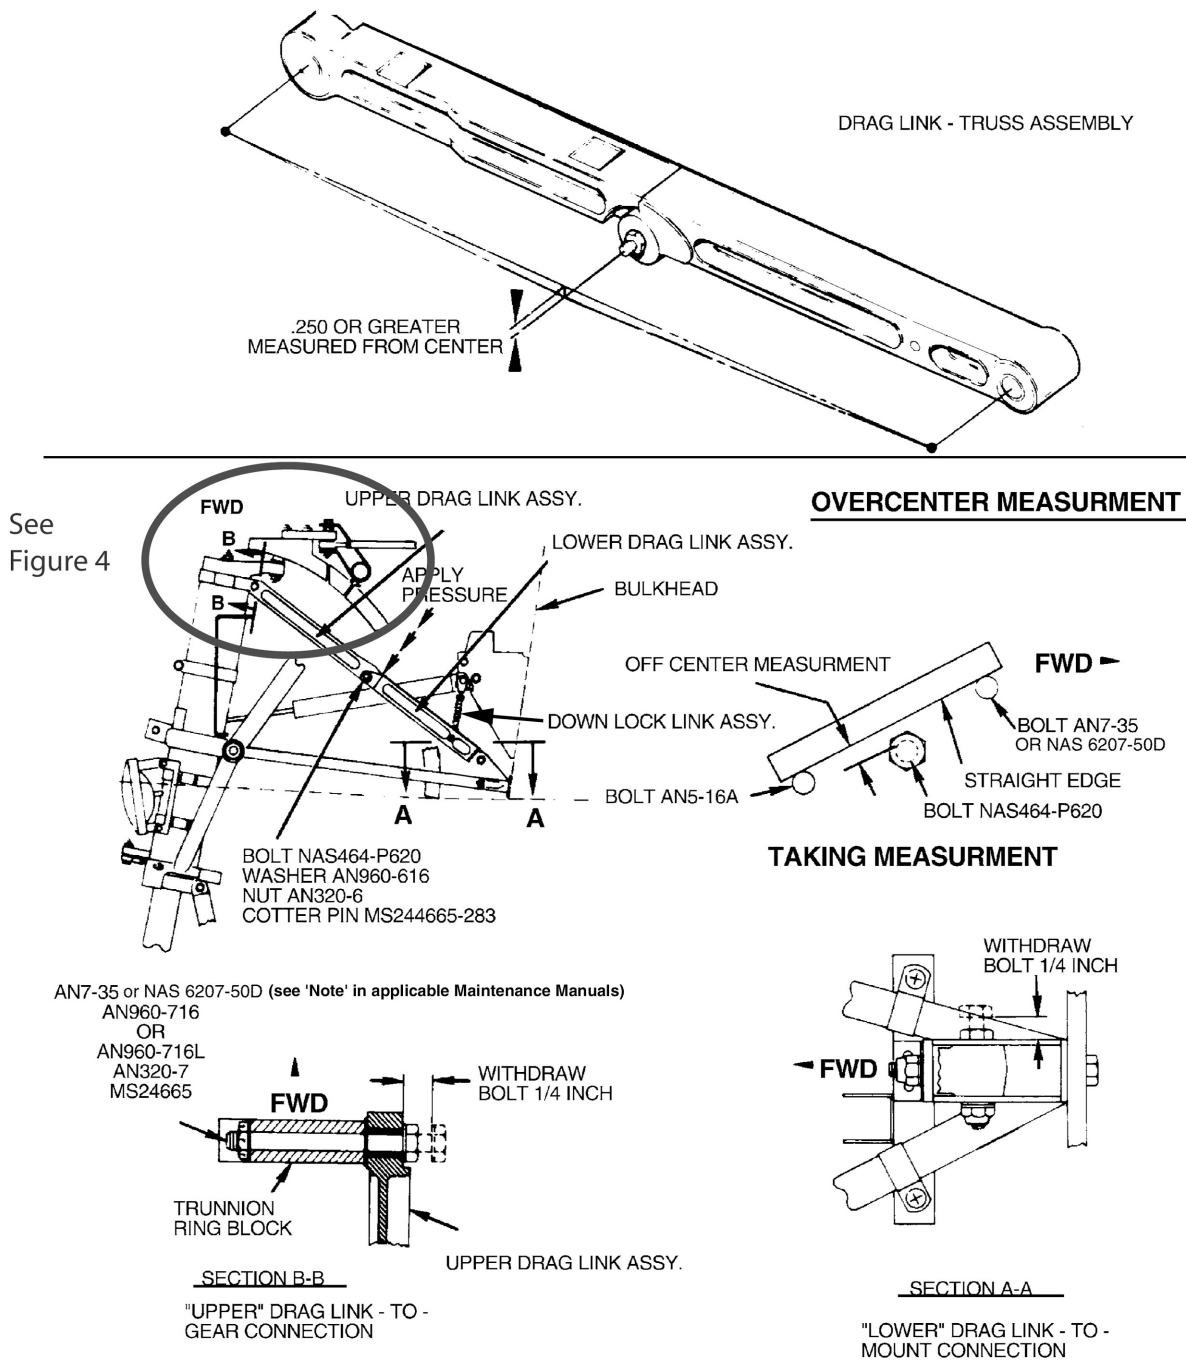
Figure 3
Drag Link Over-Center Measurement
Nose Gear Installation

- a. For Senecas serial numbers 34-7250001 through 34-7450220: Rigging of the nose gear installation (Item 13, Table 1) shall be accomplished per this Service Bulletin. The 'over center' measurement for the Seneca, as for all Senecas, shall be 0.250 or greater as measured from the center (See Figure 3). The Service Manual will be revised to delete reference to Service Bulletin 413. All required measurements are in this service bulletin and will be incorporated into the Service Manual.

- b. For Senecas II through V: Rigging of the nose gear installation (Item 13, Table 1) shall be accomplished per the appropriate Service Manual with the following exception for the Seneca II. The 'over center' measurement for the Seneca II, as for all Senecas, shall be 0.250 or greater as measured from the center (See Figure 3). The 0.250 dimension supersedes the 0.300 dimension which was incorrectly stated in the Seneca II Maintenance Manual. Refer to the Maintenance Manual for the procedure to make the over center measurement. This Service Bulletin supersedes Service Bulletin No. 413, Nose gear Drag Link Dimension Check.

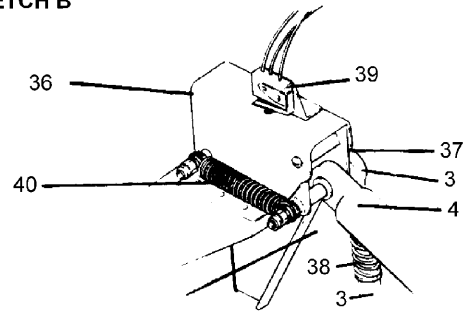
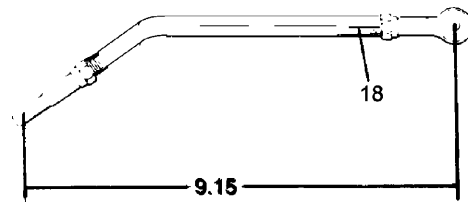
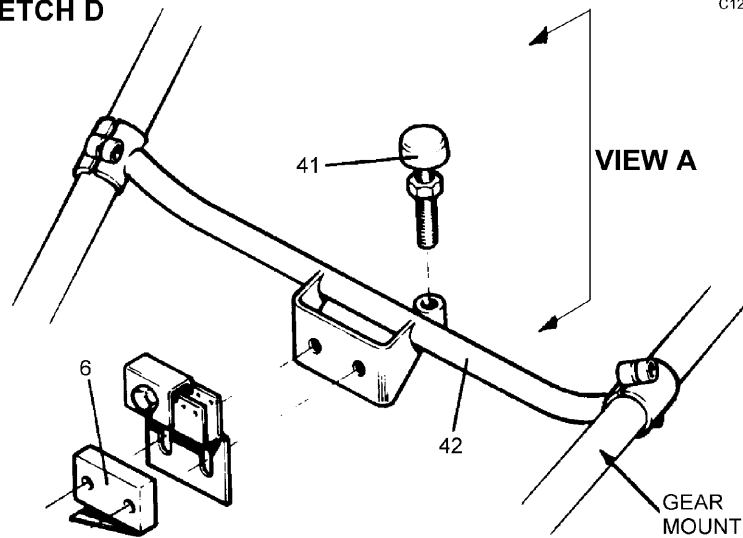
Figure 3A
Nose Gear Installation

NOTE: Upstop NOT installed on PA-34-200 aircraft S/N 34-7250001 through 34-7350135 unless Kit 760-699 has been complied with.

- e. At the actuator housing attachment assembly (see Sketch B, Figure 3A), disconnect the retention spring from the retraction link fitting.
- f. Position the gear in its down locked position and check that the drag links have fully extended to their through center position with the stop surfaces in contact.

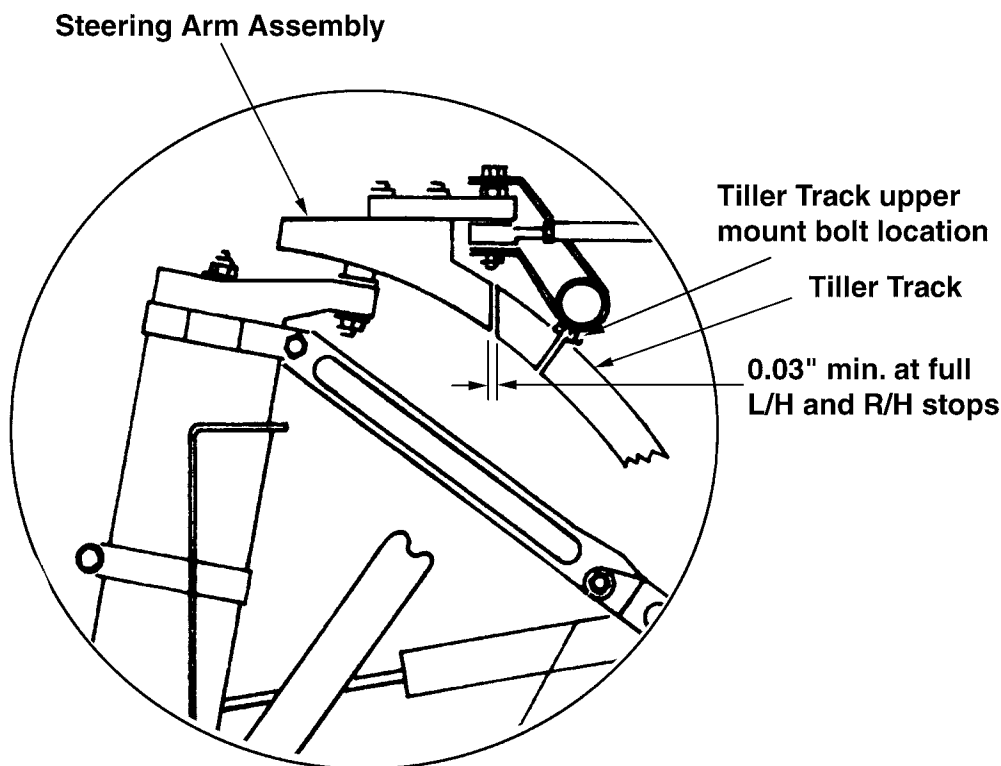
Figure 4
Steering Arm Channel Clearance

- a. Turn the nose gear full travel and make sure the clearance between the steering arm assembly and the tiller track is a minimum 0.03 of an inch at both the left and right stops. (see Figure 4). If insufficient clearance is obtained, loosen the upper mounting bolts for the tiller track and move the track upwards in the slotted holes where the track is attached to the gear mount assembly. Adjust to obtain a minimum clearance of 0.03 of an inch. Tighten the upper mounting bolts.
