# ***Exhaust Valve Lapping***

## ***Exhaust Valve Lapping***

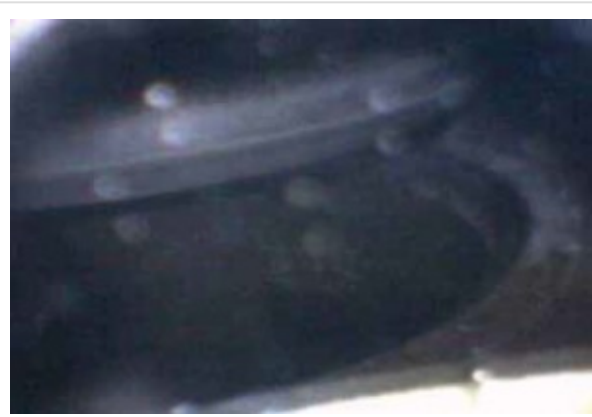
Not a great picture but the post lapping shows good contact on the valve and seat, all the way around.

A cloth is snaked into the chamber to clean the compound from the mating surfaces of the valve and seat for inspection. A properly finished product will yield a dull but complete and even ring all the way around both parts. The width of this surface should be about 1/8" wide. If there are still significant areas that didn't get resurfaced, the grinding process can be repeated.

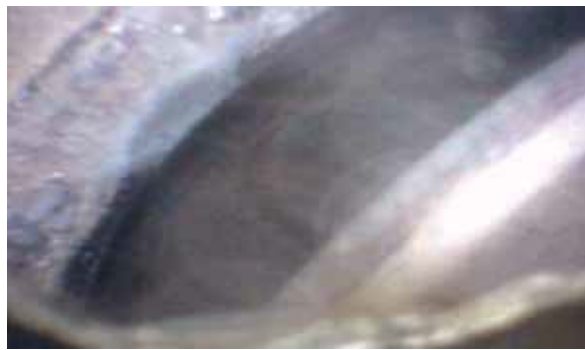
Almost too late for this seat. You can see where erosion has begun.

The debris escaping from the combustion chamber is a real problem when it is sandwiched between the exhaust valve and the seat. This debris can stick in place which prevents the valve from fully closing. Over a period of time, the gap created allows enough hot gases to escape during the combustion event that it can erode a trail in a spot on the valve or the seat. Over time, this spot endures far more heat than it can handle, and the valve “burns.” There are other causes of burned valves as well, but this happens to be one we can easily see and work to prevent.
